*Winter thermal structure, ice conditions and
climate of Lake Champlain*

CRREL Report 80-2

Roy E. Bates

January 1980

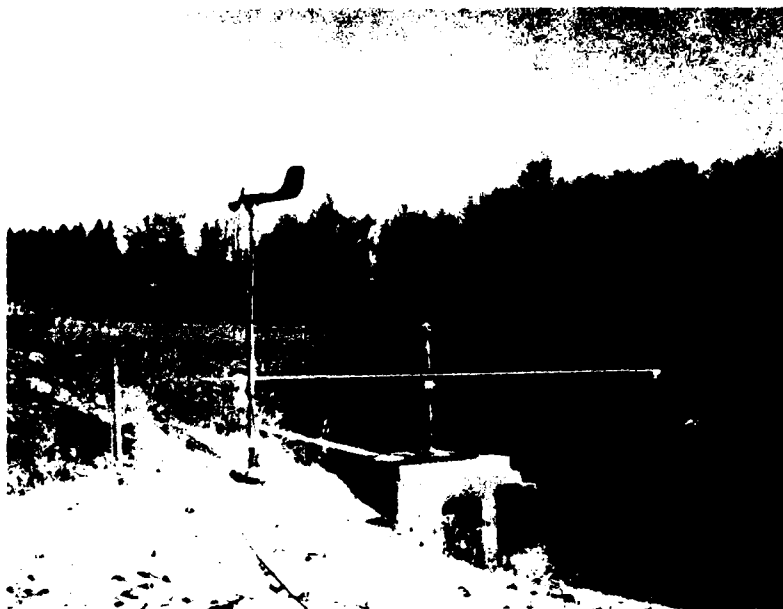
Figure 4. Gordon landing dock (solar radiation/wind site).
